July 31, 2023

Re: Sanitary Survey

Adrian Public Service District

WV3304911 Upshur County

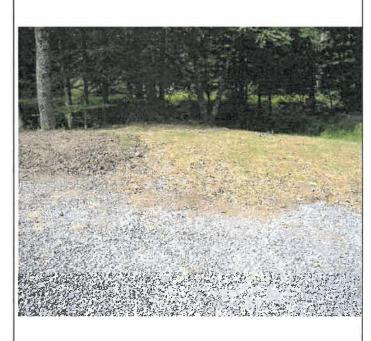
This photo shows the site for the 25 gpm Metzner Hollow BPS which will be placed into service within the next several months.

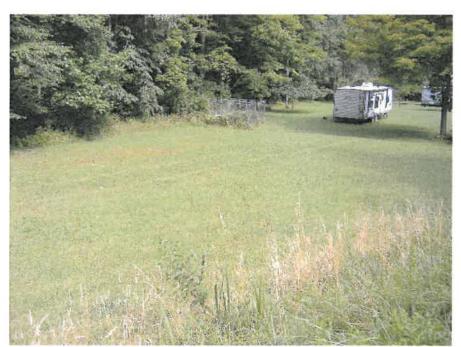
This photo shows the site of the 50 gpm Health Clinic BPS which will be placed into service in the next several months.

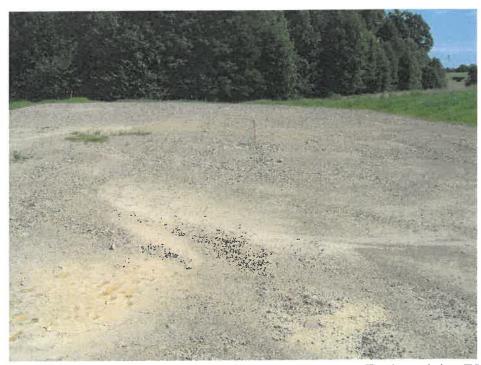
This photo shows the site for the 53,000-gallon Helvetia Tank and the 70 gpm Helvetia BPS, which should be in service within the next several months...

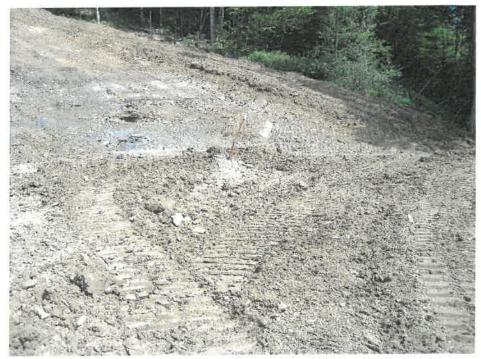
This photo shows the site for the 64,000-gallon Pickens Tank, which should be installed and in operation within the next several months.

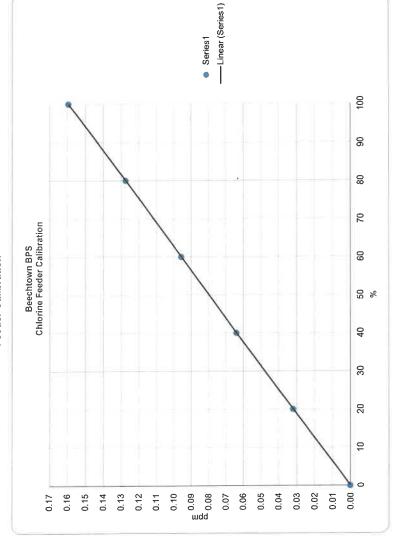
### Feeder Calibration

1 LMI Feeder rated at 0.68 gph (16.32 gpd).

2 At a feeder setting of 26%, a chlorine dose rate of ~0.04 ppm would be expected.
