July 31, 2023

Re: Sanitary Survey

Adrian Public Service District

WV3304911 Upshur County

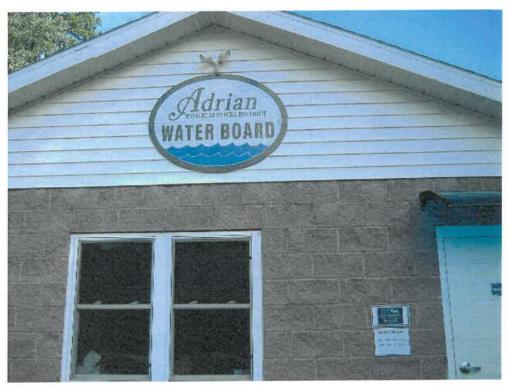
Adrian PSD office

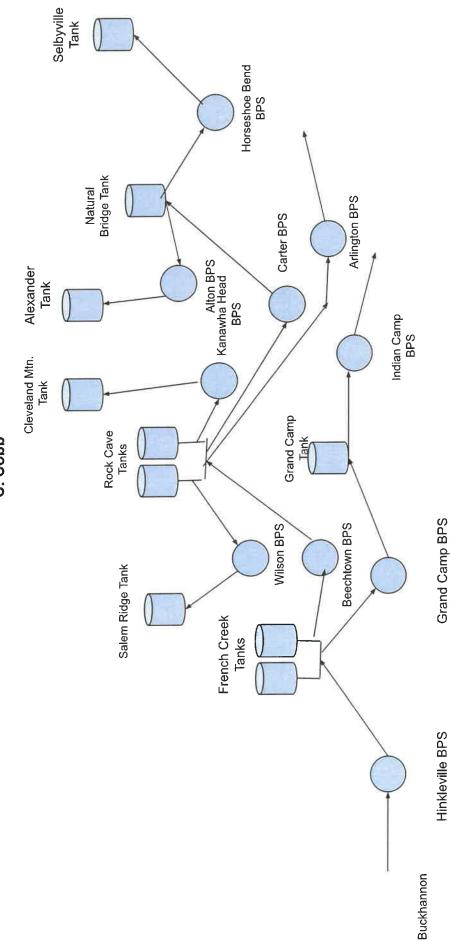
### Water Distribution System Schematic Adrian Public Service District PWSID #3304911 July 2023 C. Cobb

- 1. Indian Camp BPS maintains constant pressure to serve ~51 customers.
- Arlington BPS maintains ~235 psi discharge pressure to serve ~50 customers in the Heaston Ridge Subdivision.
  - BPSs are telemetered to the tanks they fill and tanks and BPSs are telemetered to the PSD office.
- The new Helvetia and Pickens Tanks, and the new Metzner Hollow, Health Clinic and Helvetia BPSs will be added to this schematic in the future, after being placed into service. 2, 8, 4,
